DEATH AT THE STADIUM

**REPORT ON THE FATAL USE OF AN EARLY STREAMER
EMISSION LIGHTNING ROD IN MALAYSIA**

By
Z. A. Hartono & I Robiah
March 2012
E-mail: zahartono@ieee.org

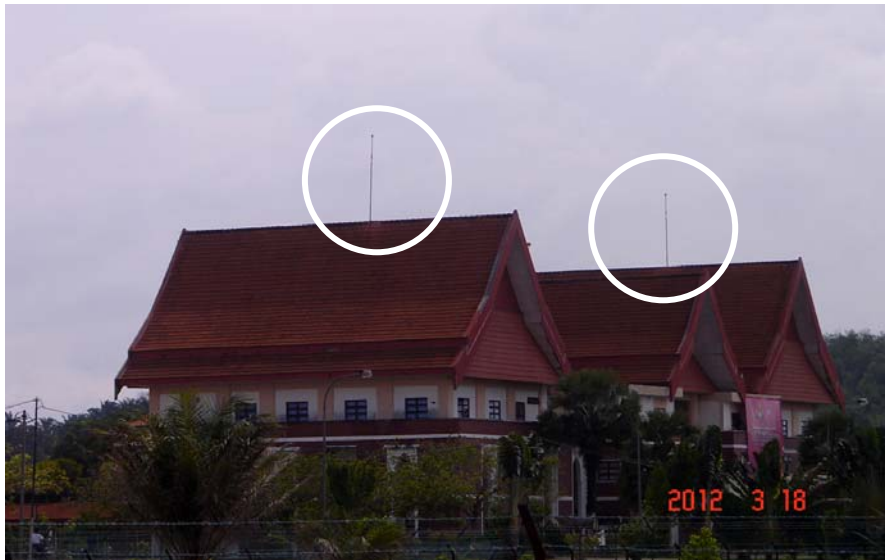
Fig. 1: KUIM administrative building with the ESE lightning rods.

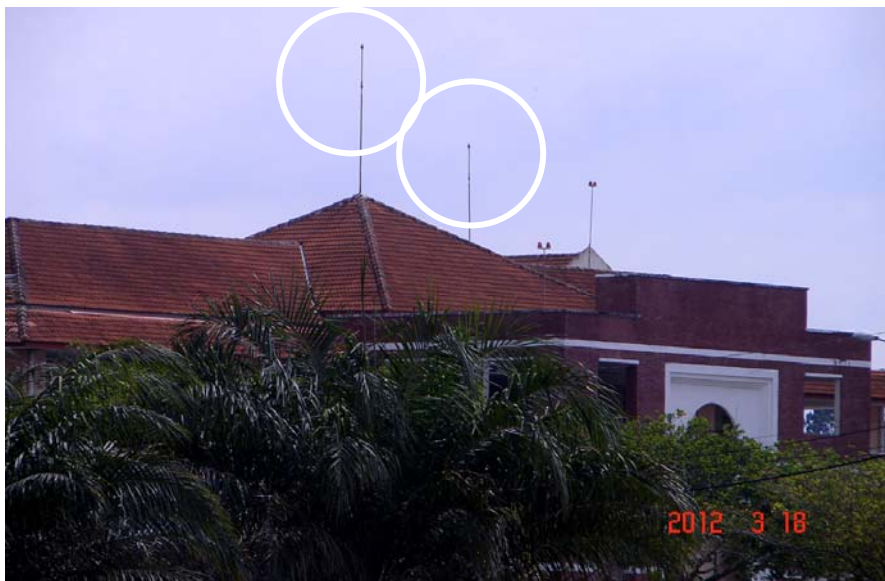
Fig. 2: Another KUIM building with the ESE lightning rods.

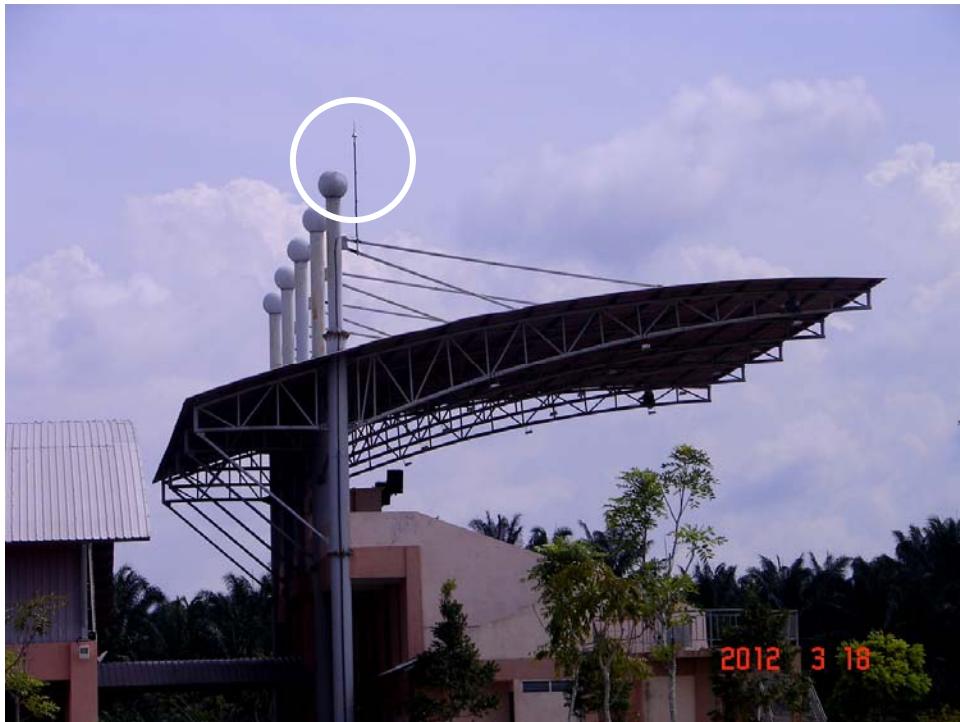
The ESE lightning rod, model Satelit manufactured by Duval Messien of France, was installed on one of the large metal poles at the edge of the grandstand. The ESE rod is grounded with a copper strip which is attached to the metal pole (Figs. 5 and 6).

Fig. 5: The Satelit ESE lightning rod mounted on the metal pole.

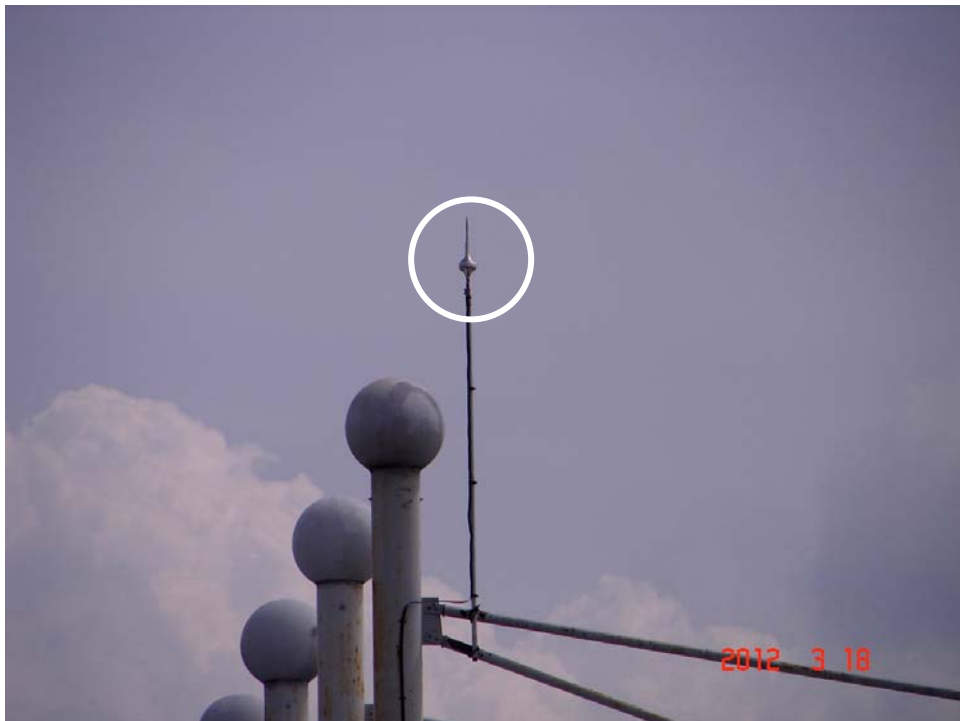
Fig. 6: Close-up photograph of the Satelit ESE lightning rod.

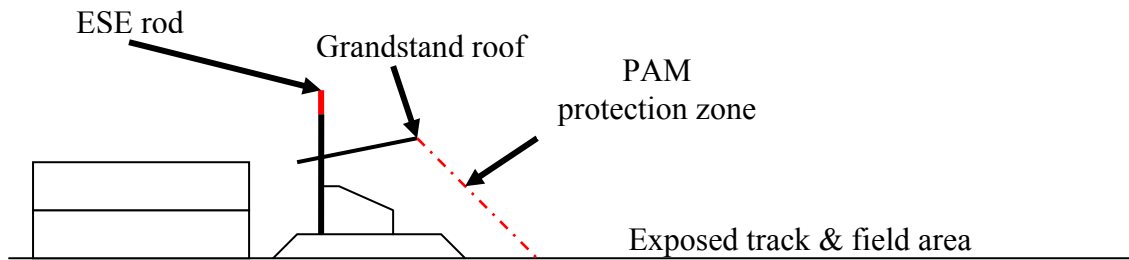
According to the Protection Angle Method (PAM) of lightning protection design, a scientifically approved method which is found in the SIRIM standard MS-IEC 62305, the grandstand roof can provide a protection coverage against direct lightning strikes which is limited to the athletic track immediately in front of it. The remainder of the track and the entire football field is exposed to the danger of lightning strikes.

Fig. 7: Protection zone according to SIRIM standard

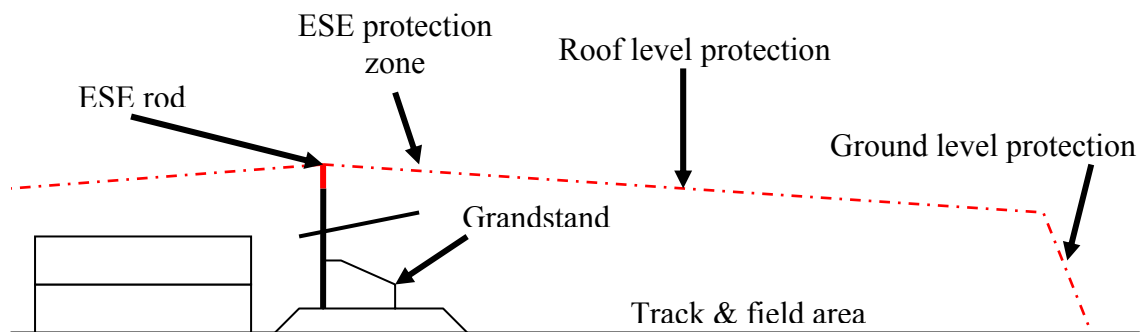
When this ESE lightning protection method is applied to the KIUM stadium, the claimed ESE protection zone will include most, if not all, of the football field and athletic track at KIUM (Fig. 10). Every project consultant who is competent in lightning protection engineering knows that buildings with robust metal roofs do not need protection against lightning strikes, hence the ESE lightning rod installed on the KIUM grandstand was for the purpose of open area protection only.

Fig. 10: The claimed ESE protection zone at the KIUM mini-stadium.

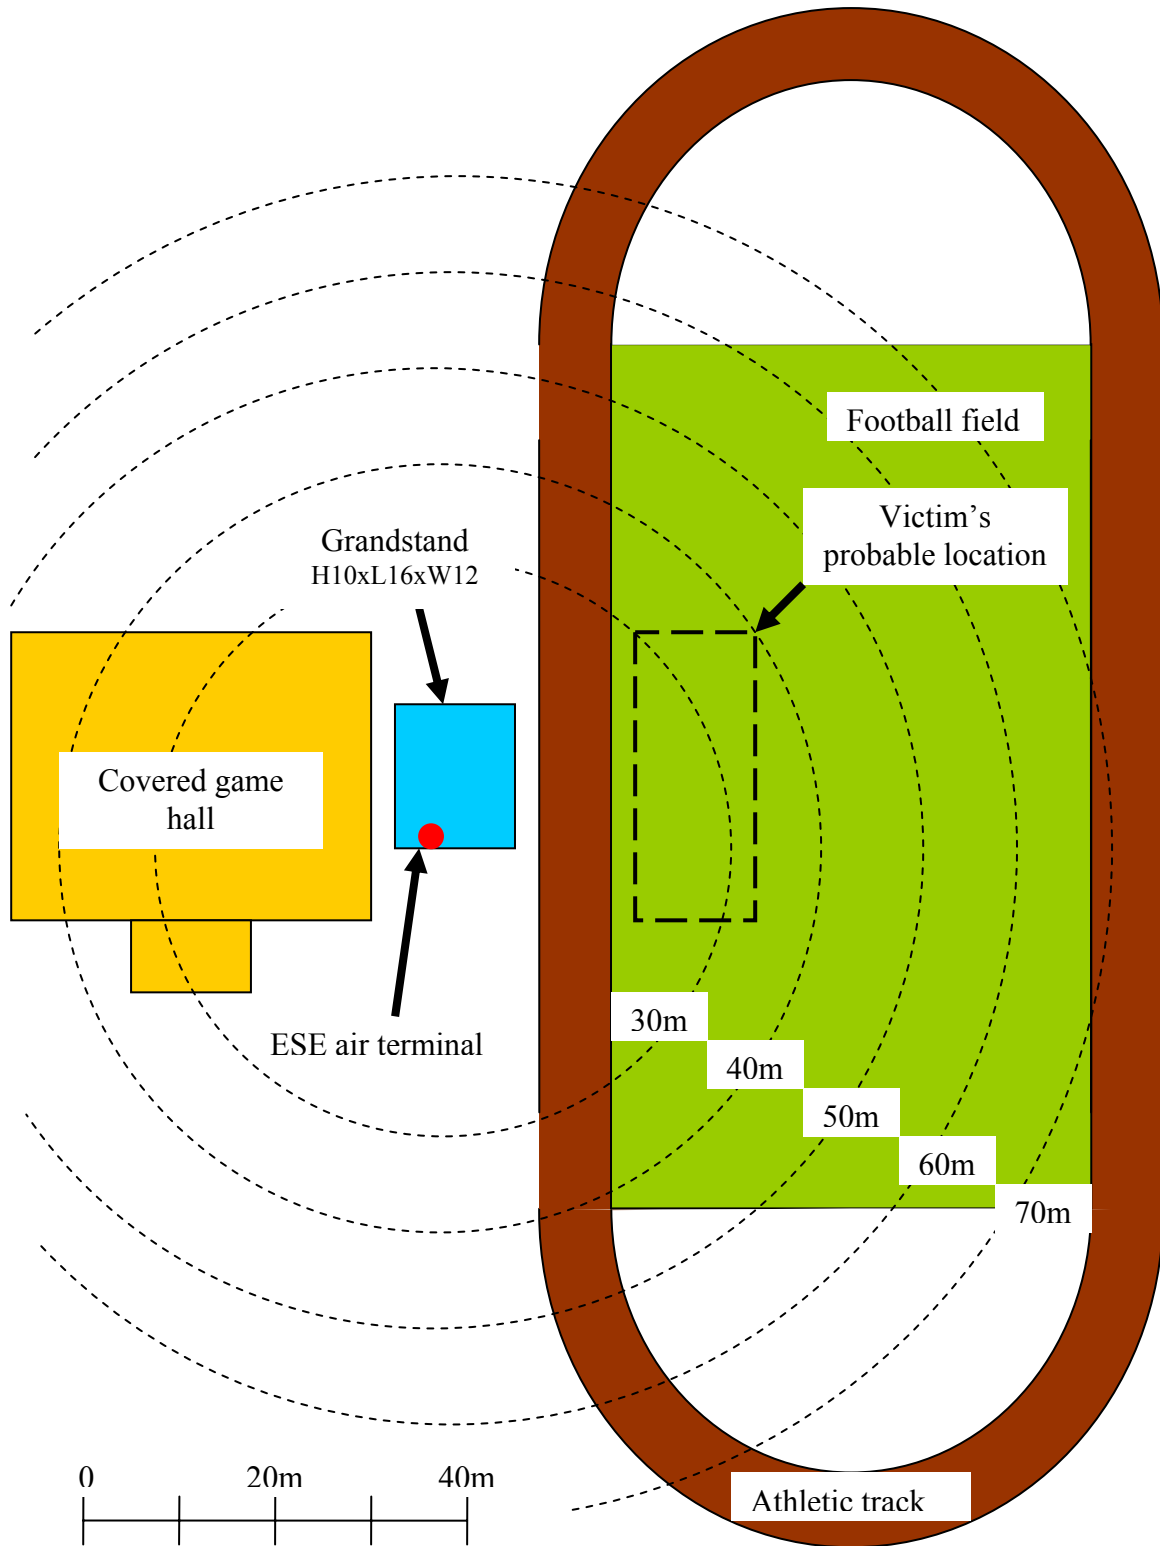
According to a news report, the victim and his friends took shelter in the grandstand when heavy rain and lightning interrupted their football practice that evening. When the downpour became a drizzle, they went down to the football field and was just about to restart their football game when the victim was struck by lightning. This would place the victim’s location somewhere on the football field in front of the grandstand when he was struck i.e. within about 40 m from the ESE lightning rod (Fig. 11).

According to another news report, the victim and his friends was near the edge of the football field when the incident occurred. If that was the case, he would have been much closer to the ESE lightning rod than estimated above.

This incident is another indisputable evidence of the failure of the ESE lightning rod with fatal consequences since the victim was clearly within the claimed protection zone of the rod when he was struck by lightning. With hundreds of recreation sites around the country using the ESE lightning rods as protection for open areas, it will not be long before another student or member of the public fall victim to a direct lightning strike.

Fig. 11: Plan diagram showing the location of the ESE lightning rod and the victim.

Project consultants who recommended the installation of the ESE lightning rods around the country for the past 20 years should be investigated by the relevant professional bodies for professional negligence since they have clearly breached the organisation’s code of ethics on public safety and have clearly neglected the nation’s standard on lightning protection. They should be held responsible for any fatal and non-fatal incident that had occurred in the past that are related to lightning since the public had relied on their professional knowledge to ensure their safety. The project consultants should also be compelled by the authorities to replace all the ESE lightning rods with SIRIM compliant systems before another lightning incident occurs.

Like any other products that are severely lacking in safety features, the relevant government ministry should recall all ESE lightning rods until they can be certified as effective and safe to use by recognised international technical organisations such as CIGRE. While conducting studies on the ESE lightning rods, CIGRE have found firm evidence of the ESE lightning rod failures (in Malaysia) more than a decade ago.

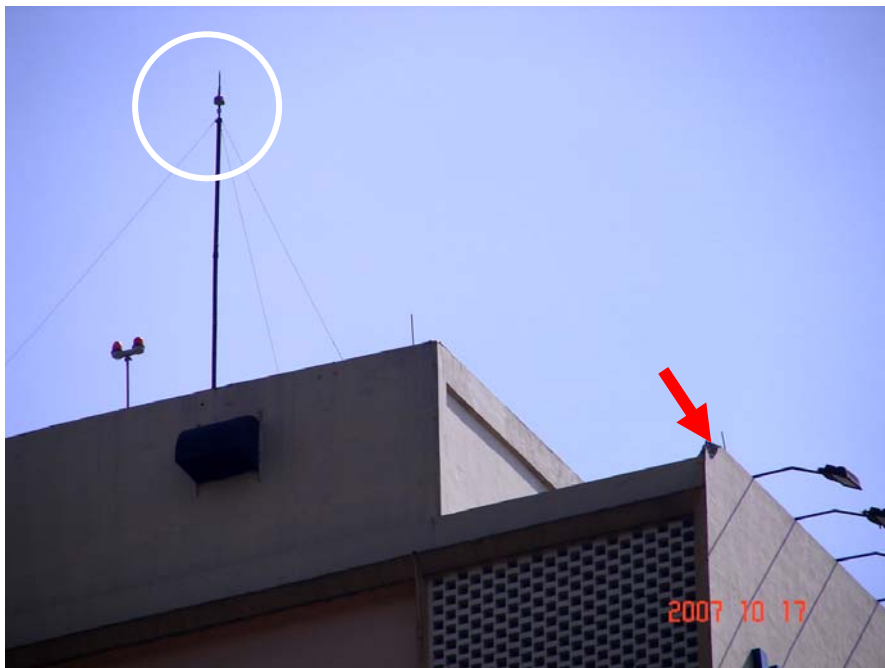
Hence, it is not surprising that the victim in this incident was struck well within the claimed ESE protection zone. In fact, the failure of the Satelit ESE lightning rod has been observed in a number of cases within Kuala Lumpur. One of them is shown below (Fig. 12).

Fig. 12: The Wisma Tanah building in 2007 (before the damage was repaired).

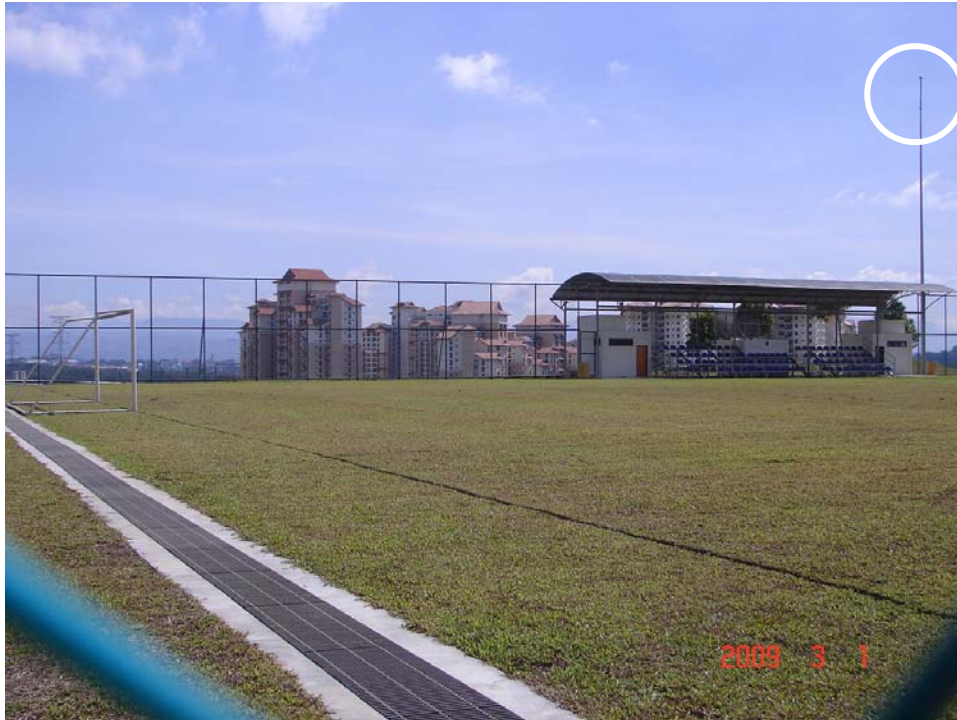
This school field is situated on top of a barren hill and is therefore considered as a high risk lightning location. An ESE lightning rod has been installed beside an all metal mini-grand stand (Figs. 13 and 14).

Fig. 13: An ESE lightning rod installed on a school field in Putrajaya.

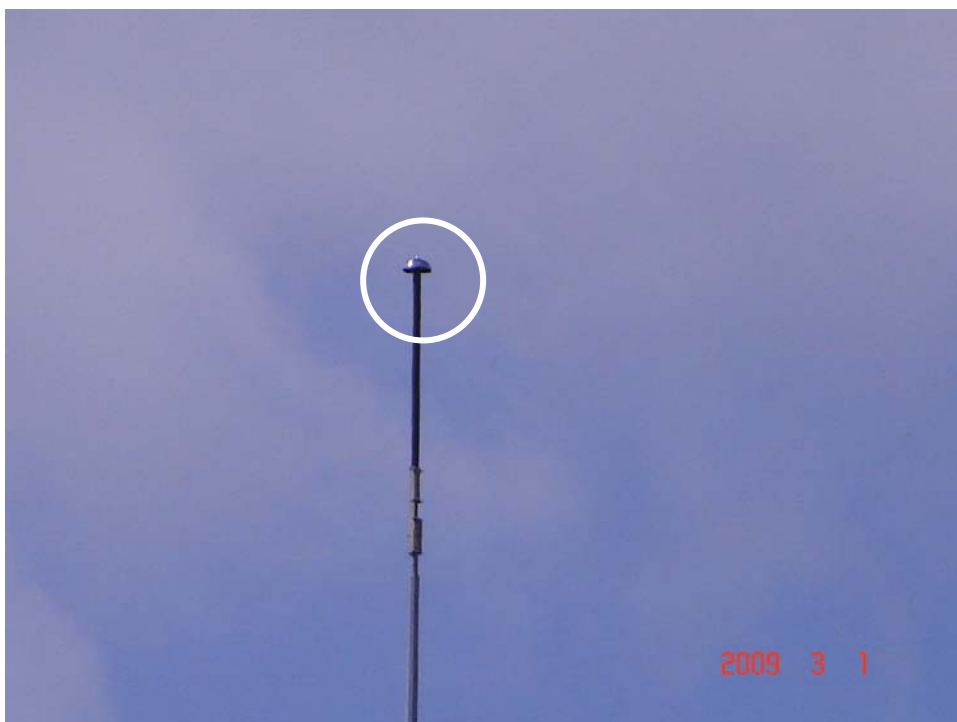
Fig. 14: A close-up photograph of the ESE lightning rod.

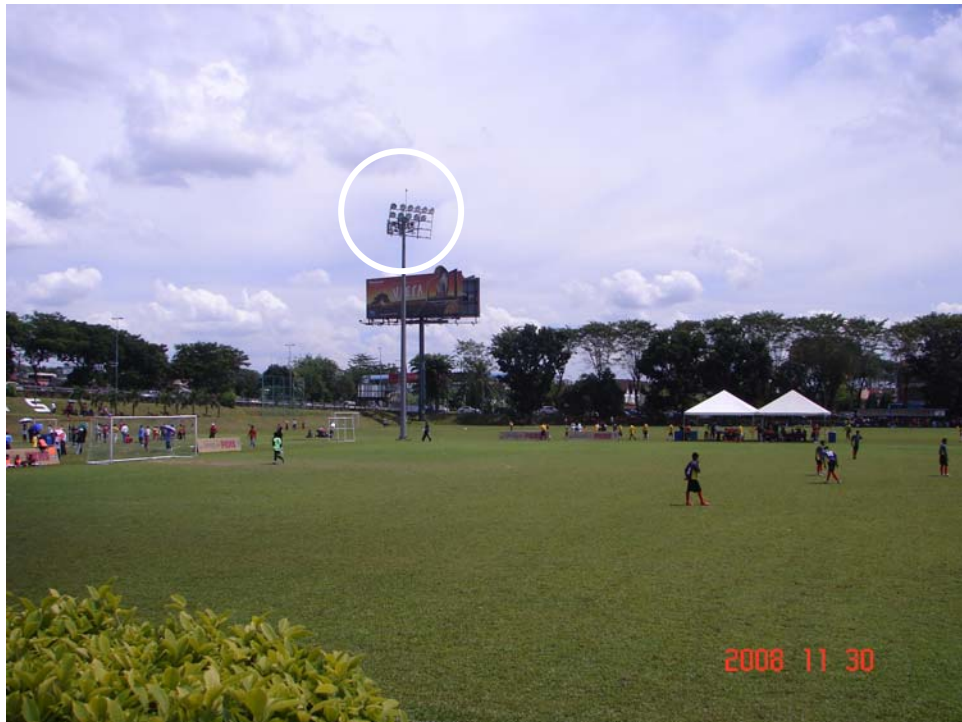
This public football field has been installed with two ESE lightning rods on the flood lights located at opposite ends of the field (Figs. 15 and 16).

Fig. 15: An ESE lightning rod installed on the floodlight of a football field.

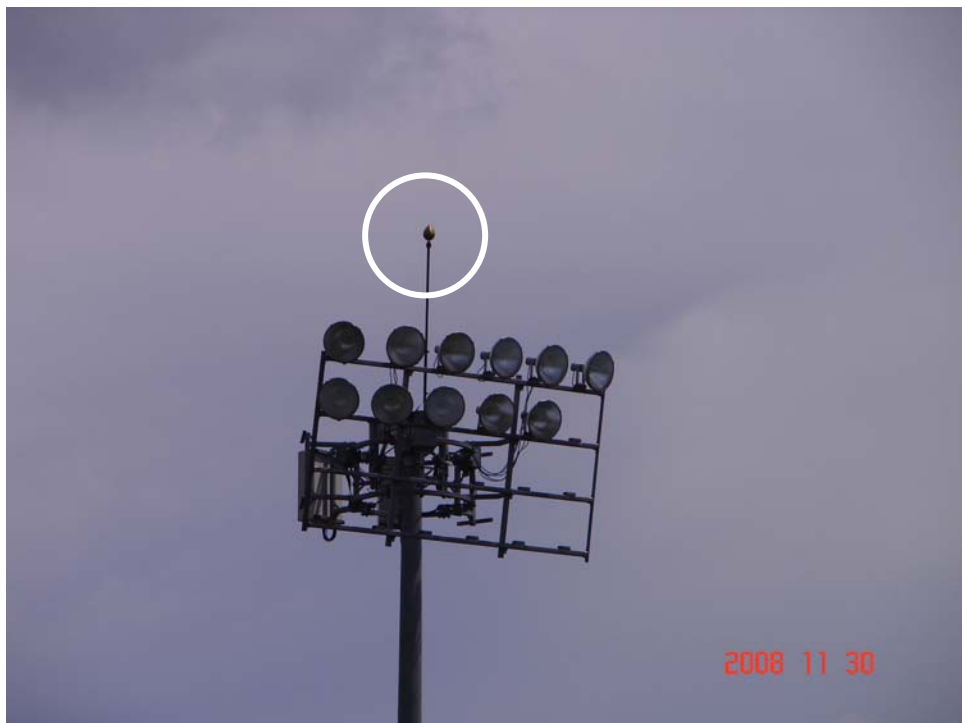
Fig. 16: A close-up photograph of the ESE lightning rod.
