DEATH AT THE STADIUM

**REPORT ON THE FATAL USE OF AN EARLY STREAMER
EMISSION LIGHTNING ROD IN MALAYSIA**

By
Z. A. Hartono & I Robiah
March 2012
E-mail: zahartono@ieee.org

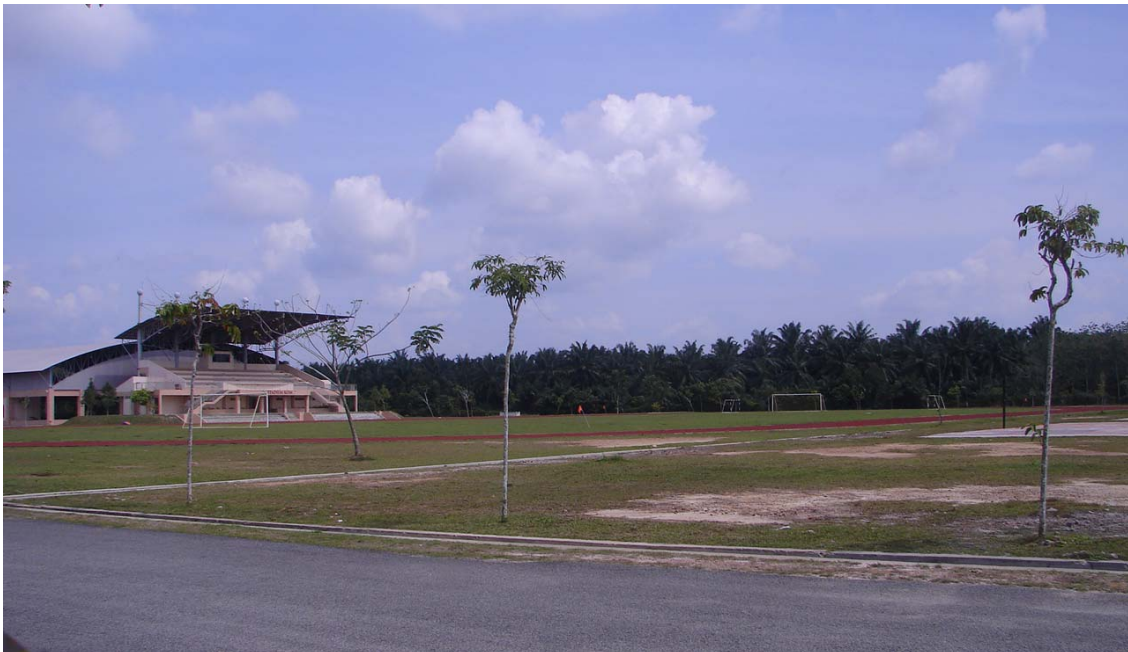
Cover picture:

The KUIM football field in front of the grandstand where the lightning fatality occurred.

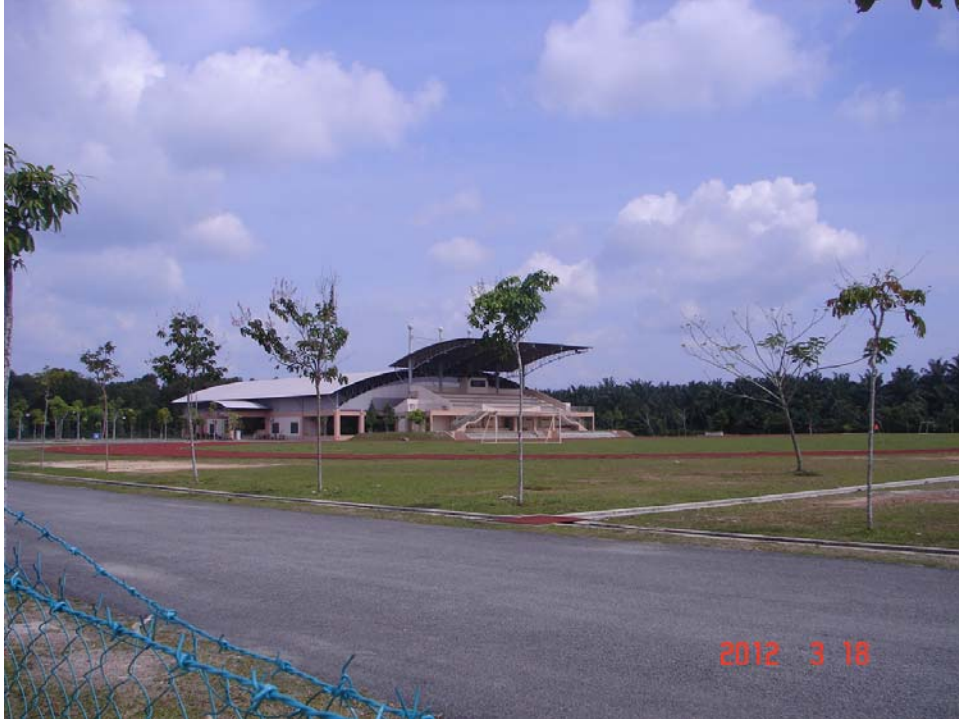
The KUIM mini-stadium consists of a grandstand, an indoor game hall, a football field and an athletic track. The grandstand, which is located about 5 m from the athletic track, is a metal roofed structure with a dimension of about 10 m high, 12 m wide and 16 m long. The metal roof is mounted on five large 12 m high metal poles (Figs. 3 and 4).

Fig. 3: Oblique view of the indoor game hall, grandstand and football field.

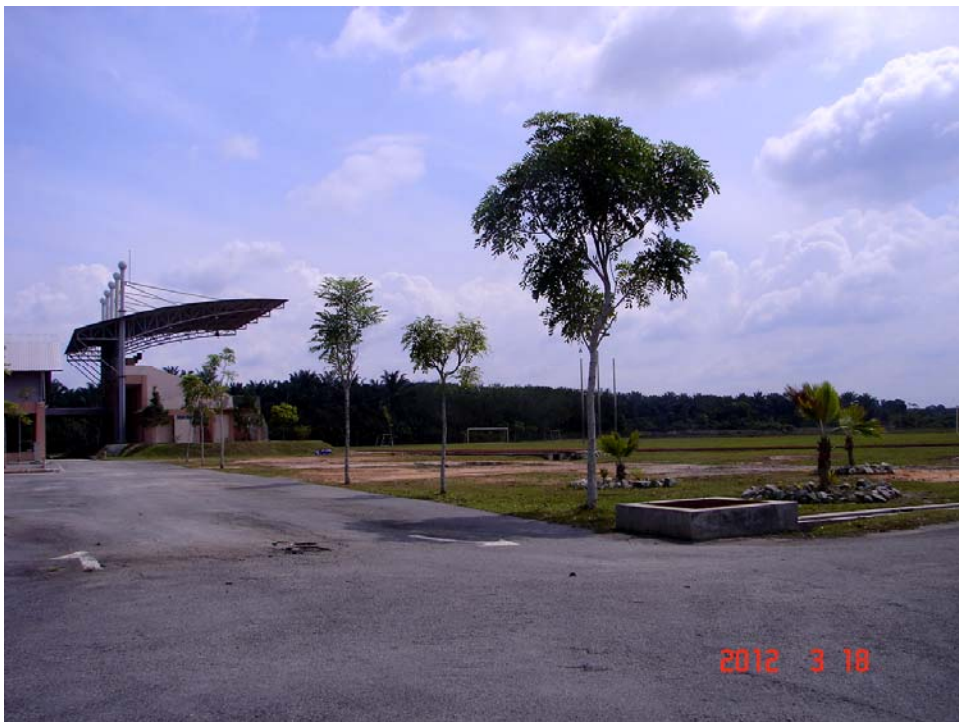
Fig. 4: Side view of the grandstand and football field.

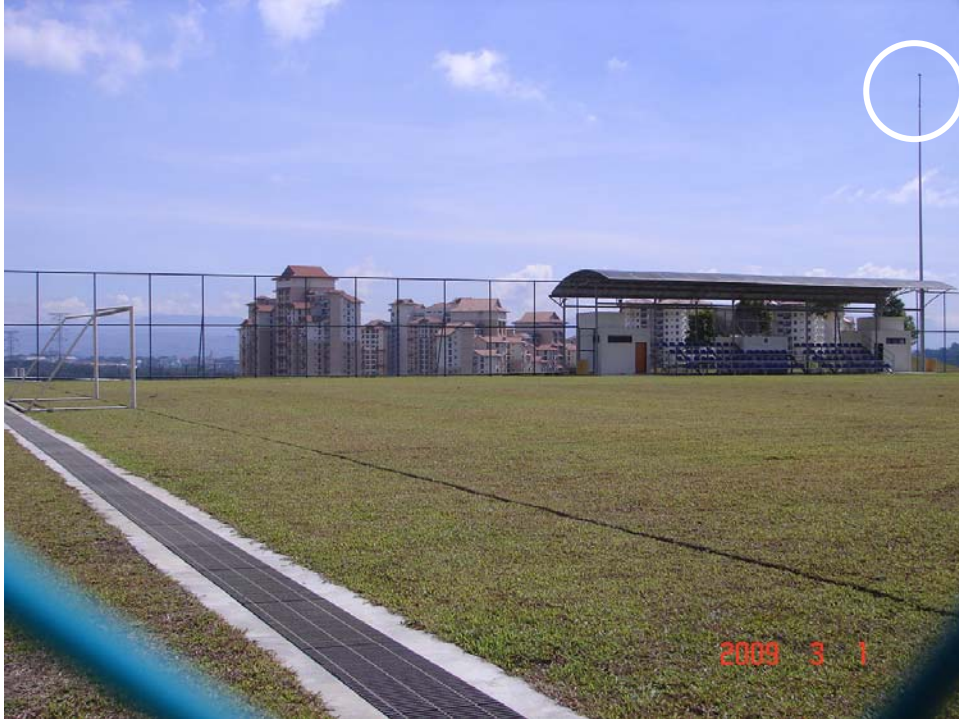
This school field is situated on top of a barren hill and is therefore considered as a high risk lightning location. An ESE lightning rod has been installed beside an all metal mini-grand stand (Figs. 13 and 14).

Fig. 13: An ESE lightning rod installed on a school field in Putrajaya.

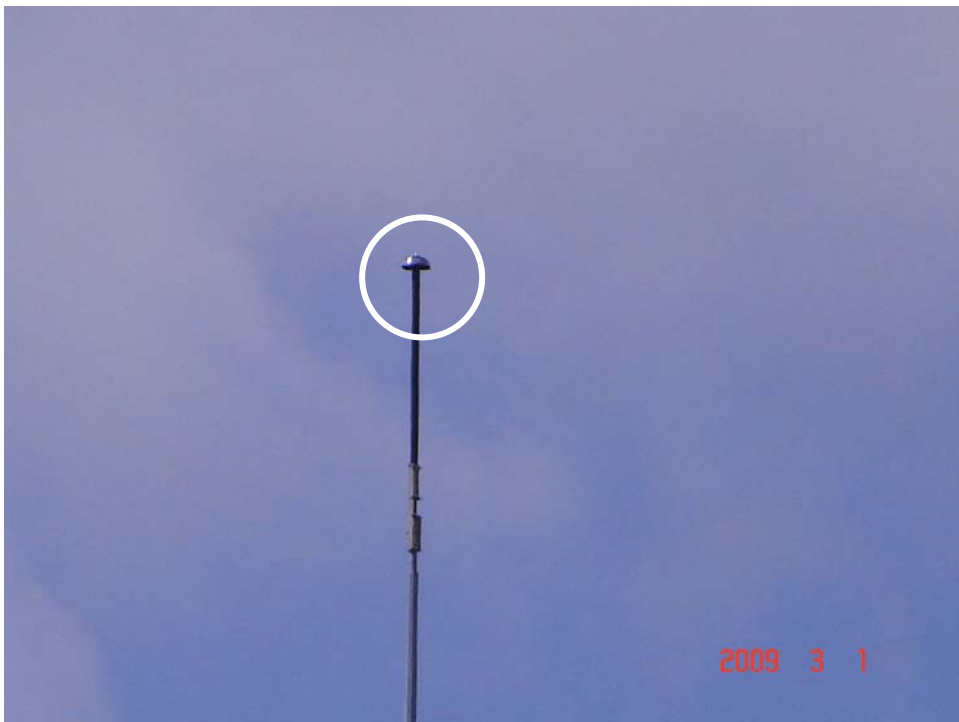
Fig. 14: A close-up photograph of the ESE lightning rod.

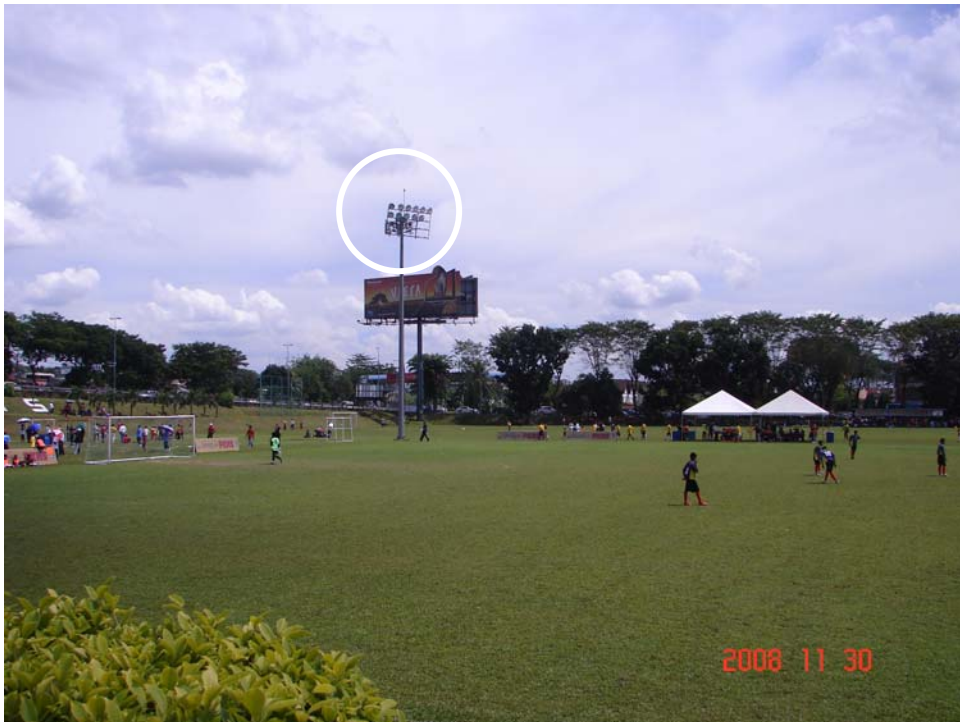
This public football field has been installed with two ESE lightning rods on the flood lights located at opposite ends of the field (Figs. 15 and 16).

Fig. 15: An ESE lightning rod installed on the floodlight of a football field.

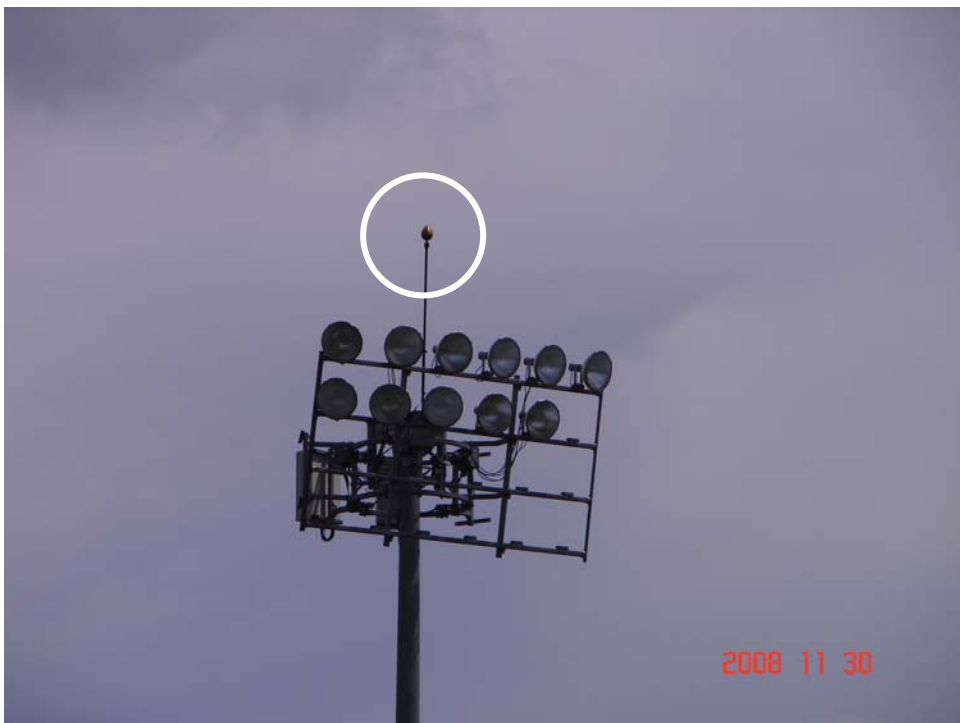
Fig. 16: A close-up photograph of the ESE lightning rod.
