LIGHTNING PROTECTION SYSTEMS

**OPERATION &
MAINTENANCE FOR
BUILDING OWNERS**

Harger Lightning & Grounding

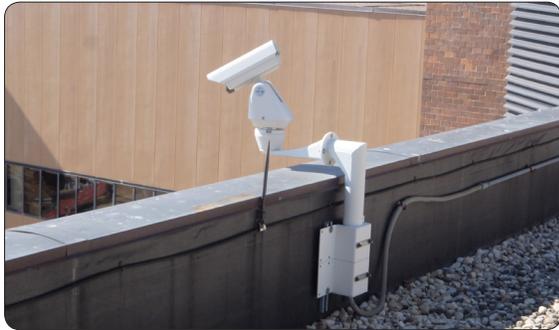
SECURITY SYSTEMS

Updated security cameras were recently installed on a large, regional medical center. The camera is susceptible to damage from a lightning strike which could further cause additional interior damage from fire due to arcing between the CCTV system and other building systems.

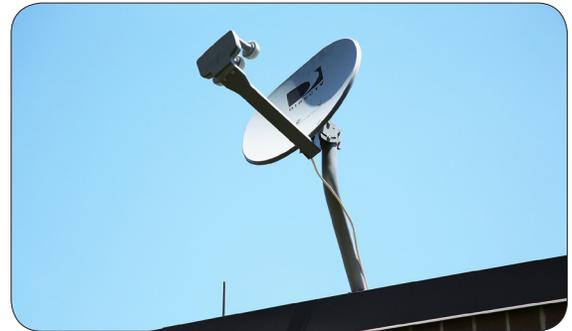
SATELLITE DISH

A satellite dish was recently added to a corporate headquarters as a backup source for internet services. The existing lightning protection system does not adequately protect this new telecommunications addition. Satellite dishes require special considerations as the protection method cannot interfere with the operation or reliability of the incoming and outgoing signals.

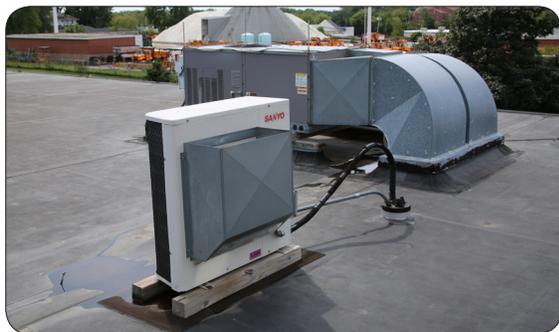
NEW HVAC EQUIPMENT

A new cooling unit was installed for a computer server room and was not tied into the lightning protection system. This unit is a mission critical piece of equipment which needs to be operational at all times. The financial implications of this unit suffering damage caused by a lightning strike makes it very clear that the existing system needs to be updated.

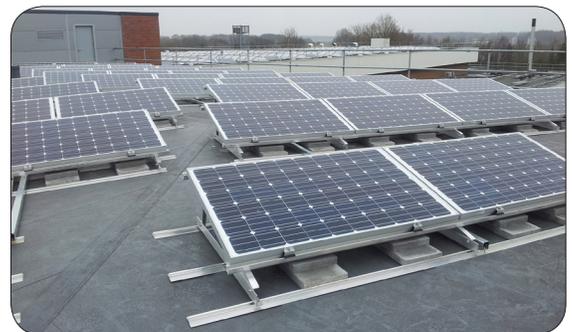
SOLAR PANELS

Multiple solar panel arrays have been added to a roof with an existing lightning protection system. It is imperative to prevent damage to the panels by promptly and effectively incorporating the new solar panel arrays into the existing lightning protection system.
