DEATH AT THE STADIUM

**REPORT ON THE FATAL USE OF AN EARLY STREAMER
EMISSION LIGHTNING ROD IN MALAYSIA**

By
Z. A. Hartono & I Robiah
March 2012
E-mail: zahartono@ieee.org

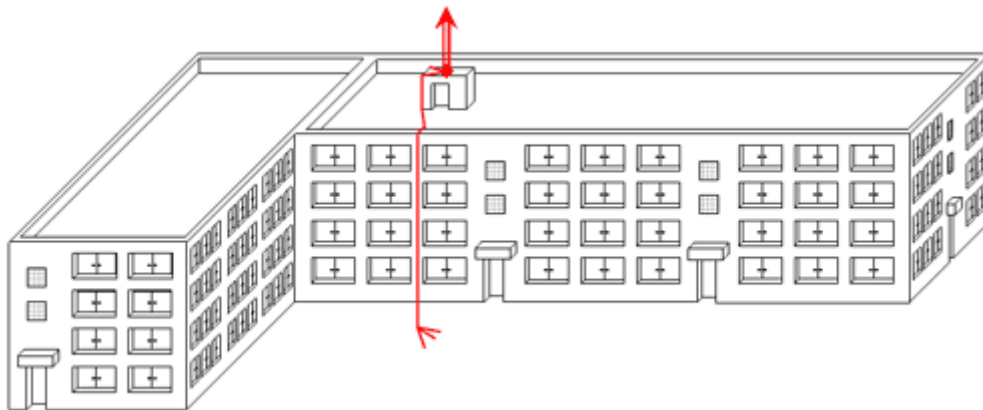
However, the manufacturers of the ESE lightning rods had claimed that their rods can provide a very large protection zone i.e. up to 100 m or more depending on the make and model of the rod. According to GIMELEC, an organisation that is affiliated to French ESE manufacturers, a single ESE lightning rod installed centrally on the roof can provide protection for the entire building and the open area surrounding the building. This is shown in the GIMELEC diagrams below (figs 8 and 9).

Fig. 8: A school building installed with a single ESE lightning rod at the centre of the roof. (Source: GIMELEC)

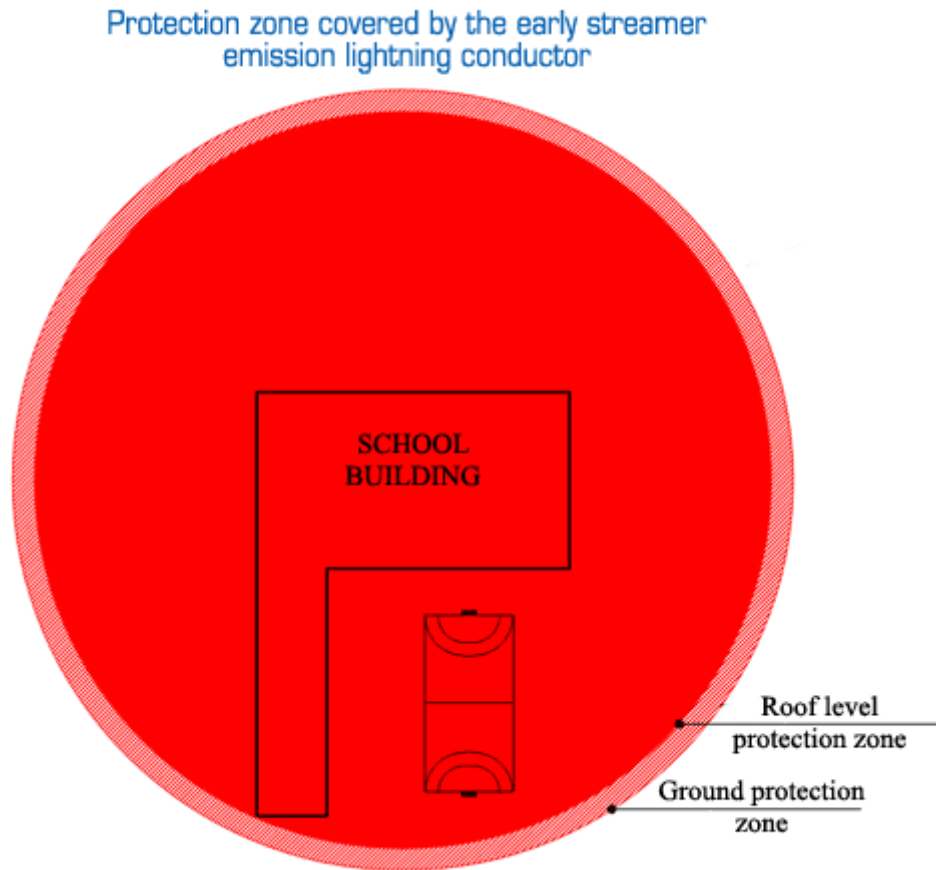
Fig. 9: The claimed protection zone provided by the single ESE lightning rod for the school building and surrounding area. (Source: GIMELEC)
