DEATH AT THE STADIUM

**REPORT ON THE FATAL USE OF AN EARLY STREAMER
EMISSION LIGHTNING ROD IN MALAYSIA**

By
Z. A. Hartono & I Robiah
March 2012
E-mail: zahartono@ieee.org

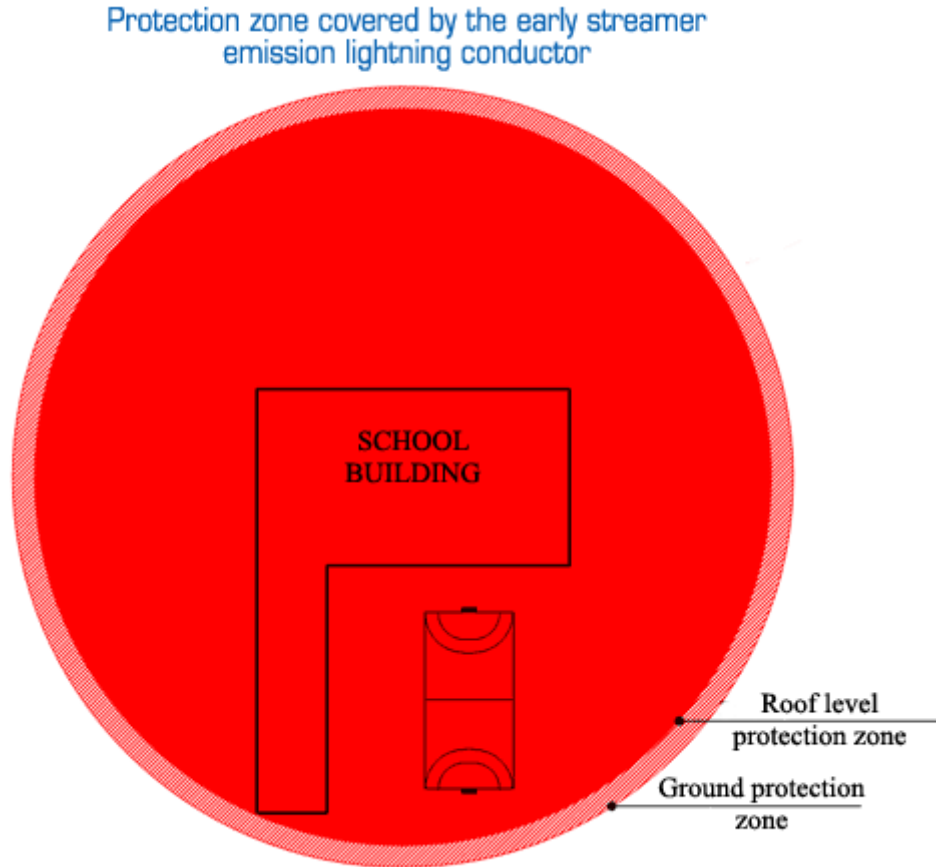
However, the manufacturers of the ESE lightning rods had claimed that their rods can provide a very large protection zone i.e. up to 100 m or more depending on the make and model of the rod. According to GIMELEC, an organisation that is affiliated to French ESE manufacturers, a single ESE lightning rod installed centrally on the roof can provide protection for the entire building and the open area surrounding the building. This is shown in the GIMELEC diagrams below (figs 8 and 9).

Fig. 9: The claimed protection zone provided by the single ESE lightning rod for the school building and surrounding area. (Source: GIMELEC)
